Manhole Inspection Summary

Manhole # S2111_015MH

Location Address: **2505 lakeland av**

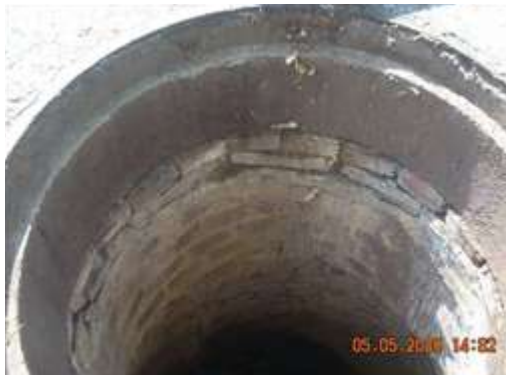
Defect 1

Frame Offset: **0** (in.) Condition: ☐ Sound ☐ Cracked ☒ **Leaks**

Infiltration: ☐ None ☒ **Joint** ☐ Cracks ☐ Mortar ☐ Roots ☐ Wall

infiltration @ chimney/frame joint. inflow
evidence from sheeting

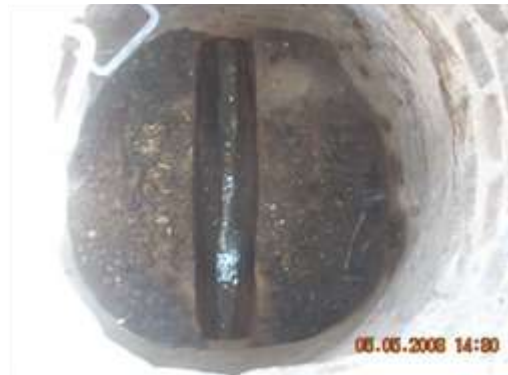
Defect 2

Condition: ☐ Sound ☐ Cracked ☐ Root Intrusion ☐ Deteriorated ☐ Leaks ☒ **Debris**

Bench Debris

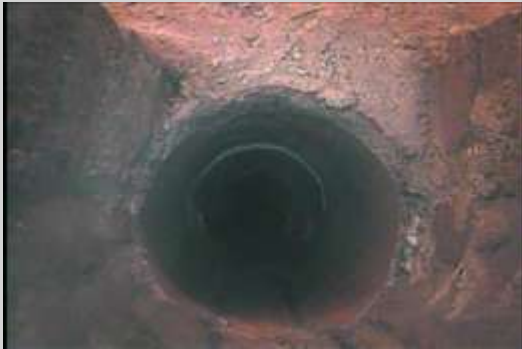
12 O'Clock Outflow

8 in. Circular Gravity Sewer
Pipe Out @ 12 O'Clock

Pipe Height: **8.4** (in.) Rod and Bar (Angled)
Pipe Material: **Clay** ☐ Pipe Lined
Invert Depth: **7.78** (ft.) Flow Characteristics: **Slow**
Deposits: ☒ None ☐ Mud ☐ Sludge ☐ Debris ☐ Grease
Silt Depth: **0** (in.) Deposits Extent:
Infiltration: **None** Pipe Seal Cond: **Sound**

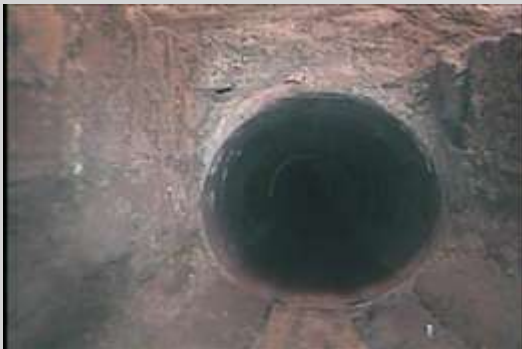
6 O'Clock Inflow

8 in. Circular Gravity Sewer
Pipe In @ 6 O'Clock

Pipe Height: **8.4** (in.) Rod and Bar (Angled)
Pipe Material: **Clay** ☐ Pipe Lined
Invert Depth: **7.47** (ft.) Flow Characteristics: **Slow**
Deposits: ☒ None ☐ Mud ☐ Sludge ☐ Debris ☐ Grease
Silt Depth: **0** (in.) Deposits Extent:
Infiltration: **None** Pipe Seal Cond: **Sound**
